Fire Resistance of Epoxy-grouted Steel Rod Connections in Laminated Veneer Lumber (LVL)

Fire Engineering Research Report 04/7

A thesis submitted in partial fulfilment of the requirements for the degree of
Master of Engineering in Fire Engineering

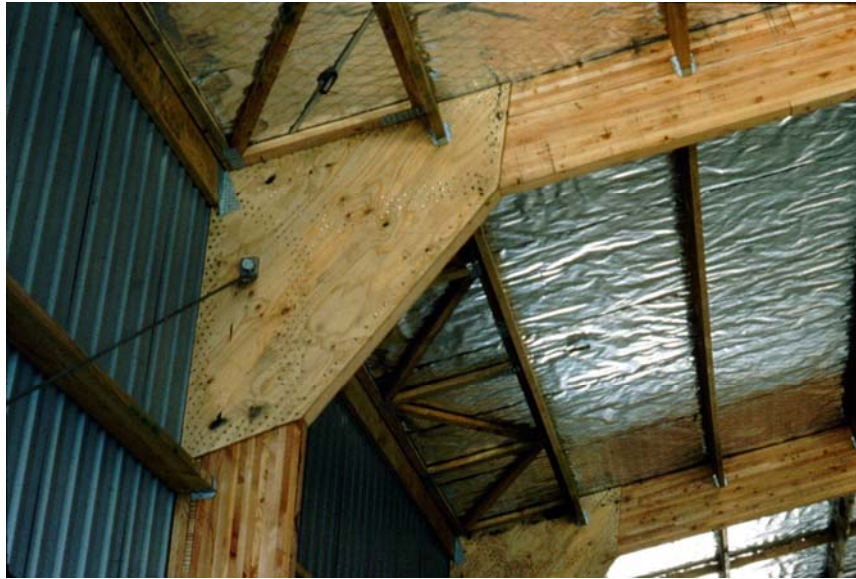
Figure 3.2 Plywood gusset plate connection

Nailed connections in heavy timber members typically involve sheets of plywood or steel either side of the intersection of two members. These connections are simple and are commonly used in portal frame buildings in New Zealand. These plywood sheets are fixed in place with rows of nails to form a rigid connection, as shown in Figure 3.2

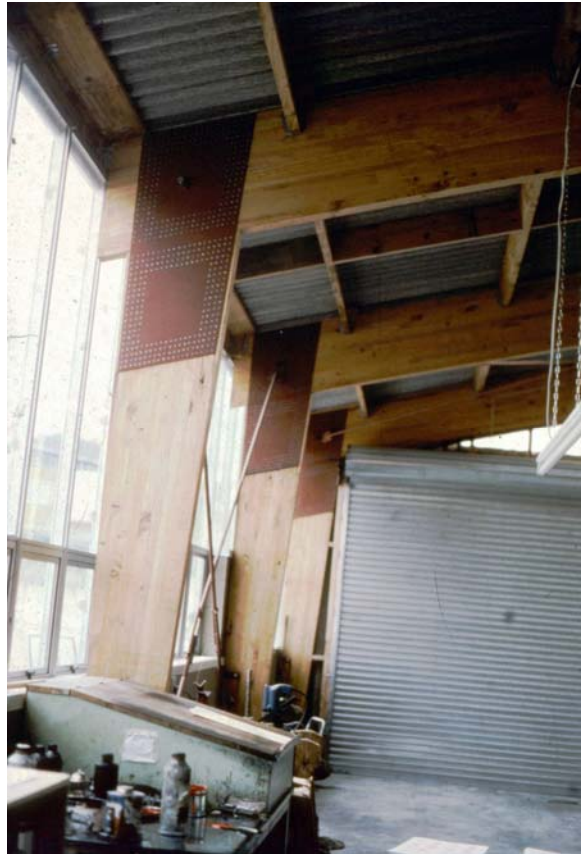
Figure 3.3 Steel gusset plate

Steel gusset plates can also be used. These have the advantage over plywood gusset plates of unrestricted size and thickness. Steel gusset plates are used in a similar manner to plywood and are attached with rows of nails, as shown in Figure 3.3. As steel is too hard to nail through, the holes in a steel gusset plate must be pre-drilled before assembly. Design of steel gusset plates is similar to those for plywood gusset plates and is also given by Buchanan (2002).

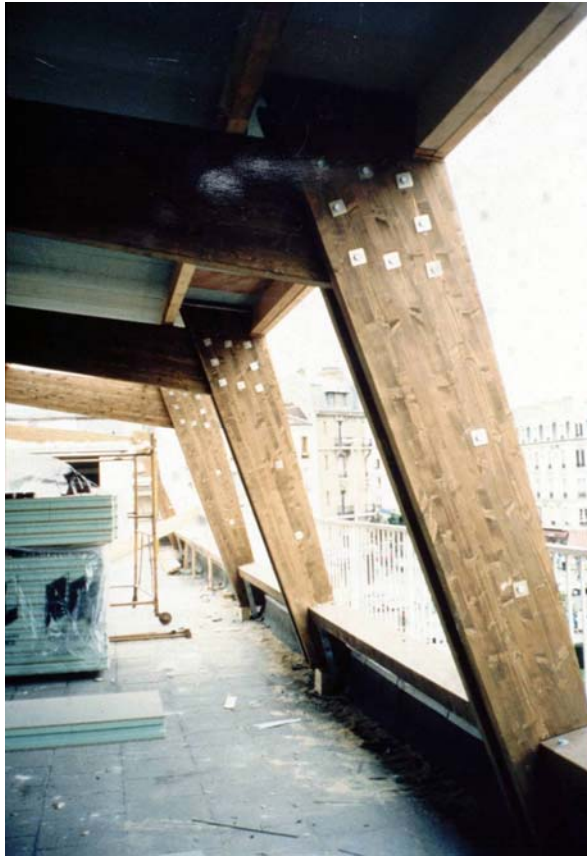
Figure 3.4 Bolted connection

Bolts can provide very strong connections, using fewer fasteners than nailed connections. Bolted connections range from simple types with bolts passing through holes in each member (as shown in Figure 3.4), or bolted connections may use external steel plates to transmit forces between members, or steel rings placed between the members (as shown in Figure 3.5).

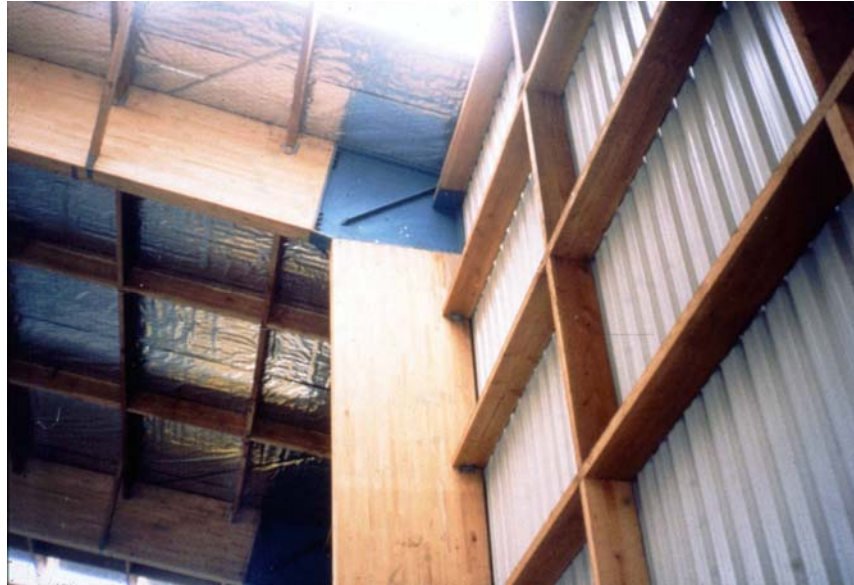
Figure 3.8 Glulam portal frame with steel hub and epoxy-grouted rods

Epoxy-grouted steel rods are very strong when glued in parallel to the grain of the timber, but are not as strong when glued perpendicular to the grain, as is the case in the rafter of Figure 3.7 (a) (Buchanan, 2002). To overcome this problem a steel hub can be used to connect the members. The use of the hub allows for all of the steel rods to be grouted in parallel to the grain of the timber, giving the greatest strength. The steel hub also allows for ductility to be designed into the connection (Buchanan and Fairweather, 1993). A schematic of this detail is shown in Figure 3.1(c) and a structure built using this connection is shown in Figure 3.8.

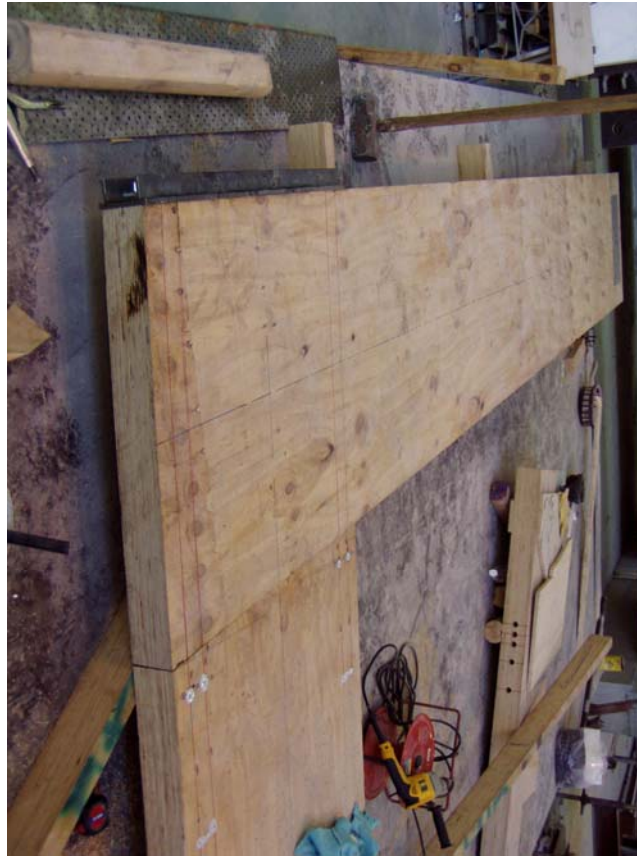
Figure 3.10 Epoxy-grouted steel rod connection in LVL timber (photo by A. van Houtte)

More recent developments in LVL have seen the emergence of a moment resisting knee joint in LVL without the use of the steel connecting hub (van Houtte, 2003), as shown in Figure 3.10. This connection by van Houtte also provides a level of fire resistance to the steel. Having an unseen connection also improves the aesthetics and allows for clean lines along the structural members.

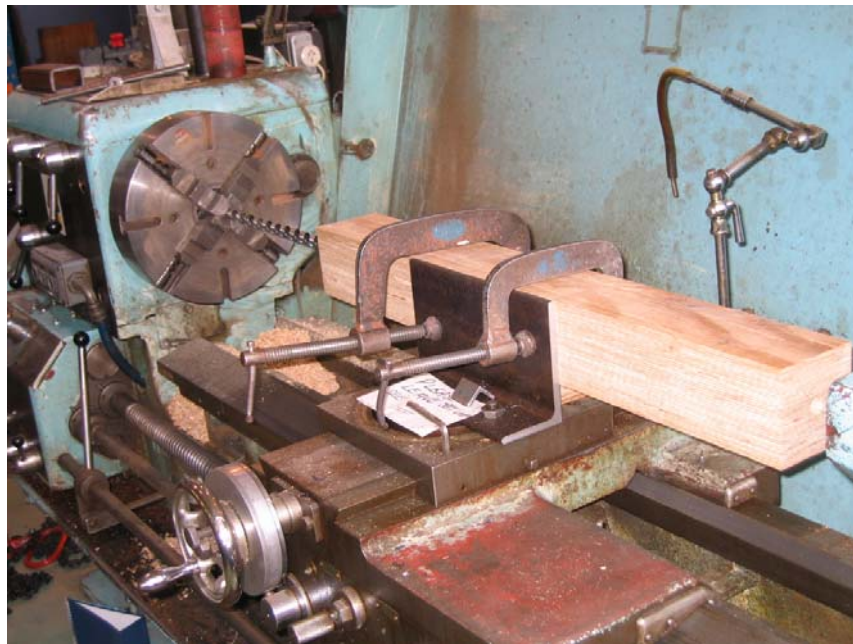
Figure 4.1 Lathe used for drilling test specimens, with drill bit in chuck and test specimen clamped to tool post.

The test specimens were clamped to a piece of steel angle section fixed to the tool post and the auger drill bit was placed in the chuck, as shown in Figure 4.1. Using the lathe to bore the holes allowed greater precision in the location, angle and depth of the holes. Holes were drilled with standard wood-drilling auger bits, which allowed holes up to 395 mm deep to be bored.

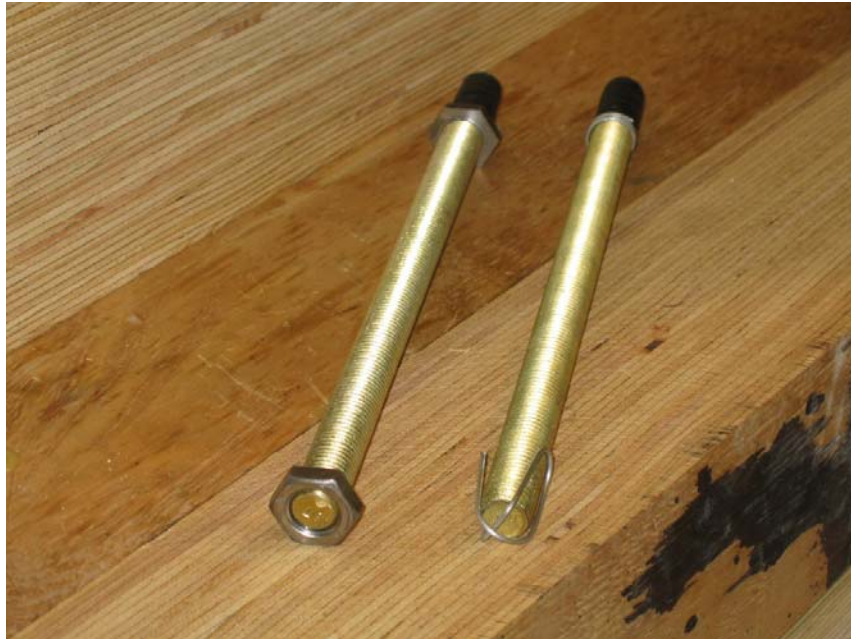
Figure 4.3 Showing the tie wire and nuts used for centring the rods in the holes

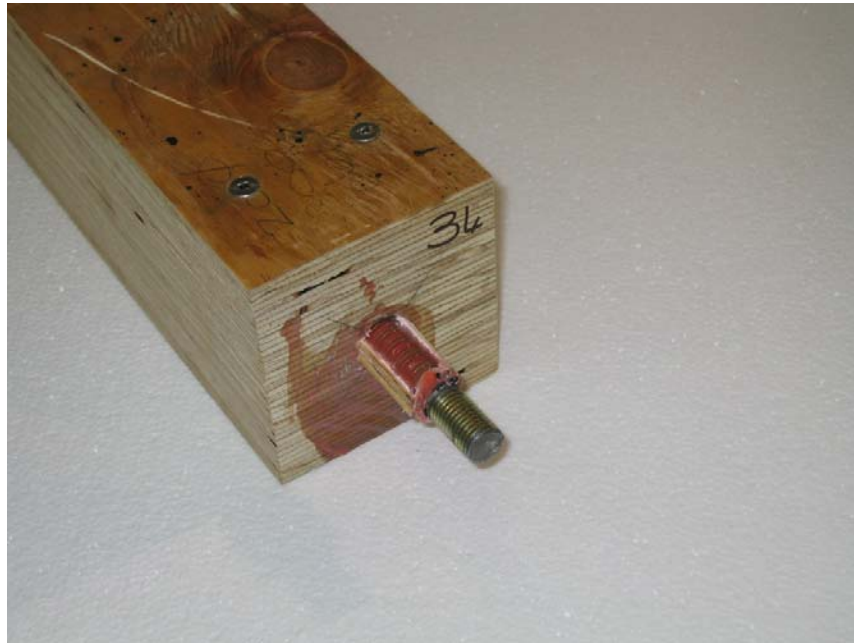
Figure 4.4 RE 500 specimen with air bubble visible after failure

Upon failure of test specimens with air bubbles, these bubbles were clearly visible, as seen in Figure 4.4. In some specimens the rods were fully removed from the test specimen for inspection and the air bubbles can be clearly, as in Figure 4.5.

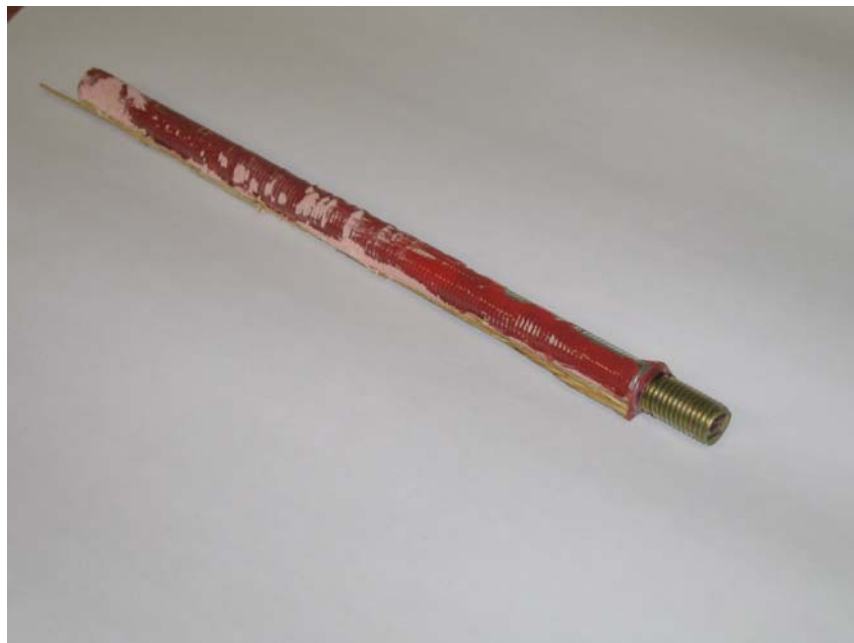
Figure 4.5 Rod fully withdrawn from RE 500 specimen, with many air bubbles (seen as dark areas) in the resin

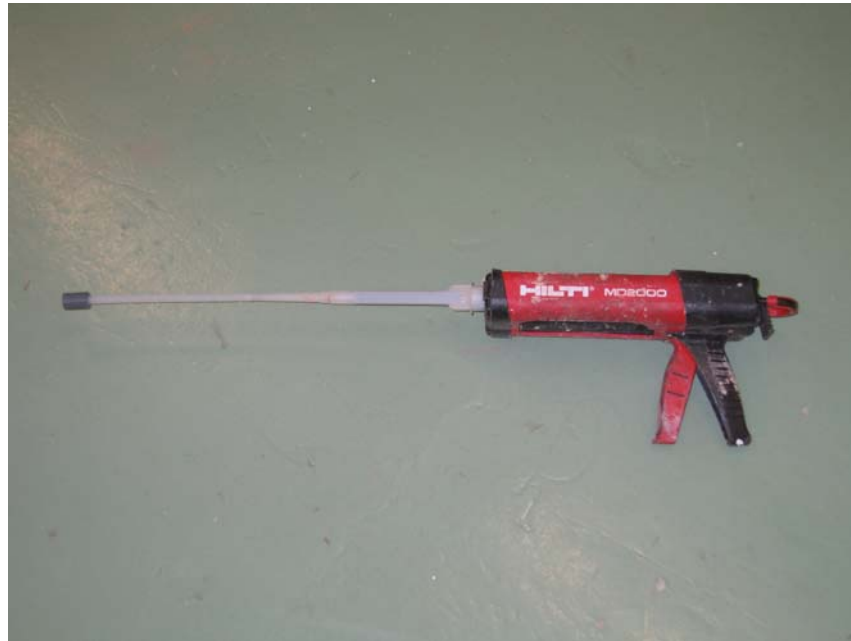
Figure 4.6 Custom nozzle for preventing air bubbles in RE 500

resin during gluing. Although these nozzles are mandatory in Europe, they are not available in New Zealand. To overcome the lack of availability a custom-made solution was prepared as shown in Figure 4.6. This nozzle consists of the standard injecting nozzle, with the supplied extension fitted. Fitted around the tip of the extension was a sleeve of plastic, which fitted tightly around the extension. The outer diameter was slightly smaller than the 20mm diameter of the hole in the timber.

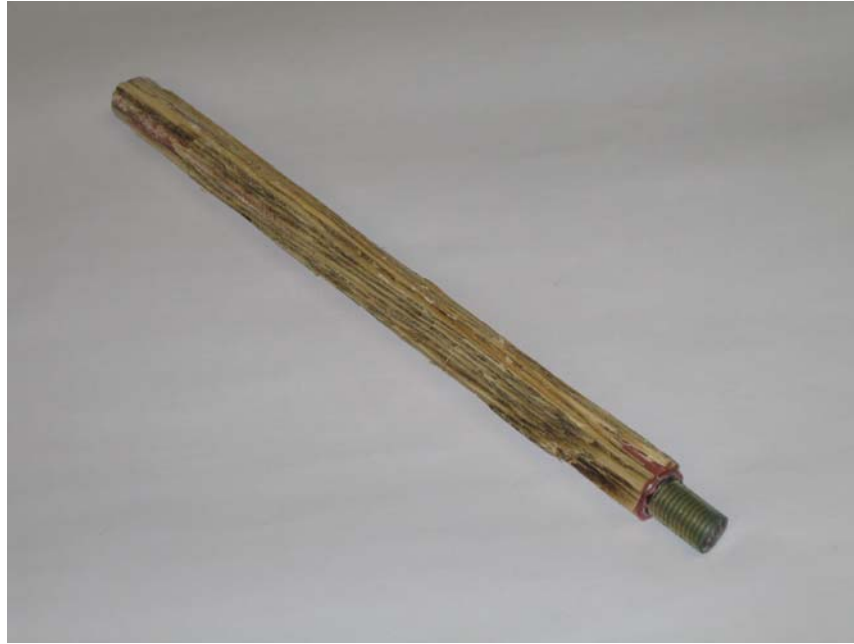
Figure 4.7 Fully removed RE 500 rod, without air bubbles in the resin

This nozzle was found to be successful, with additional test specimens giving higher and more consistent ultimate loads. This method was used for most of the RE 500 samples in this research. Using this gluing method removed the air bubbles completely, as can be seen in a rod cast using this technique in Figure 4.7. It can be seen that none of the epoxy was visible as there was bonding to the timber over the complete length of the rod.

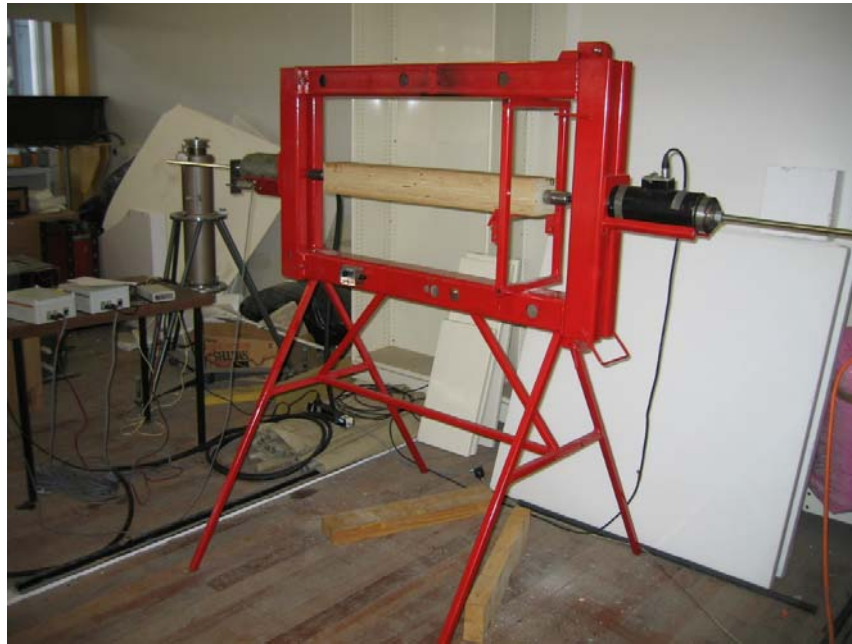
Figure 4.9 Custom-built test frame with specimen loaded

positioned much closer to the oven than the alternative testing machines, reducing the amount of cooling of heated specimens.

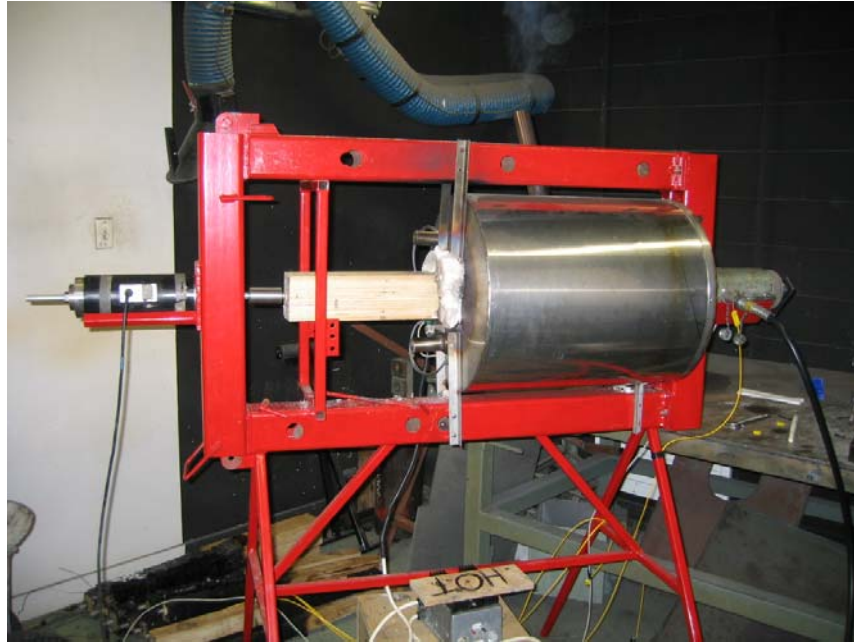
Figure 4.12 Custom-built testing frame, with furnace fitted and test specimen loaded

A custom-built testing frame with furnace was required for the furnace testing phase of this research. This testing frame was designed to allow a specimen to be held under a constant load while a heat flux was applied to the surface of the surface of the test specimen. This is the same testing frame used in the oven testing of the specimens, but with the addition of an electric furnace heater, as seen in Figure 4.12. During this phase of the research the test specimens were held under a constant tensile load while a heat flux was applied.

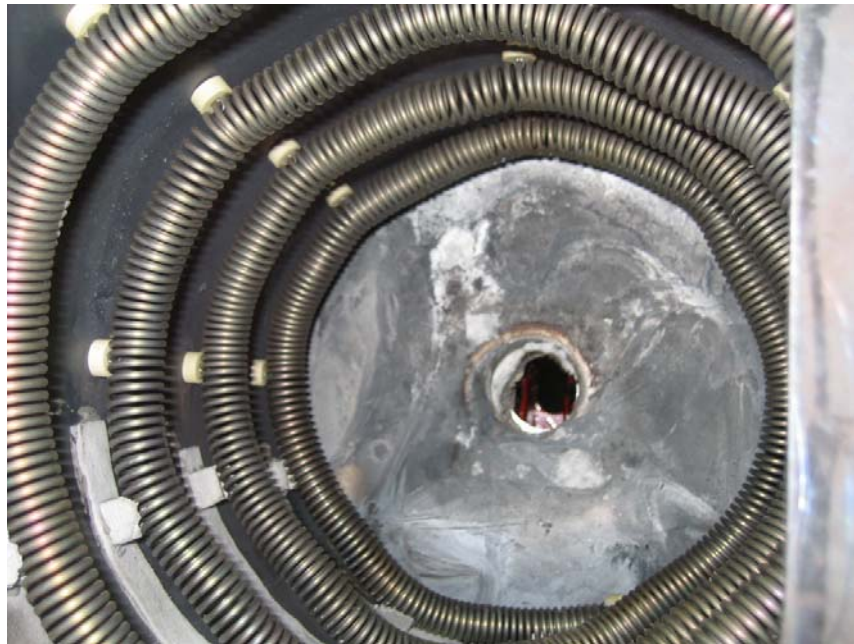
Figure 4.13 Electrical coil within furnace

This cylindrical furnace was constructed from an outer stainless steel skin, with 100 mm of Kaowool mineral insulation and a stainless steel inner skin. An electrical element was fixed to the inner skin of the furnace. The element consisted of a 5.5 kW 3.65 mm diameter kanthal aluminium electrical coil, which was fixed to the inner skin in a spiral with porcelain insulators, as seen in Figure 4.13.

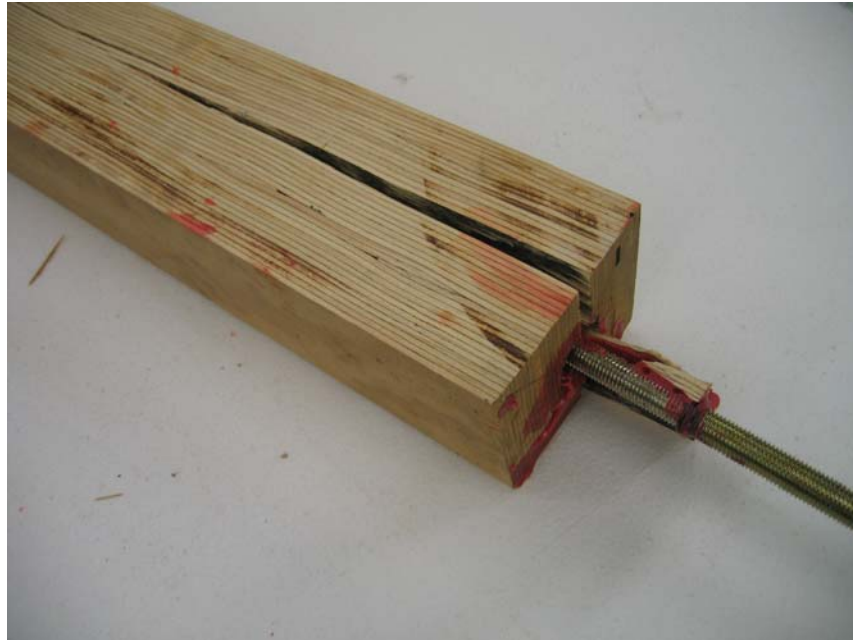
Figure 5.1 Mode 1 failure in RE 500 specimen

Although this failure mode only occurred in the RE 500 specimens it is expected that it would have occurred had the West System been tested without screws perpendicular to the lamination, as throughout the testing programme the two epoxies behaved in a similar manner.

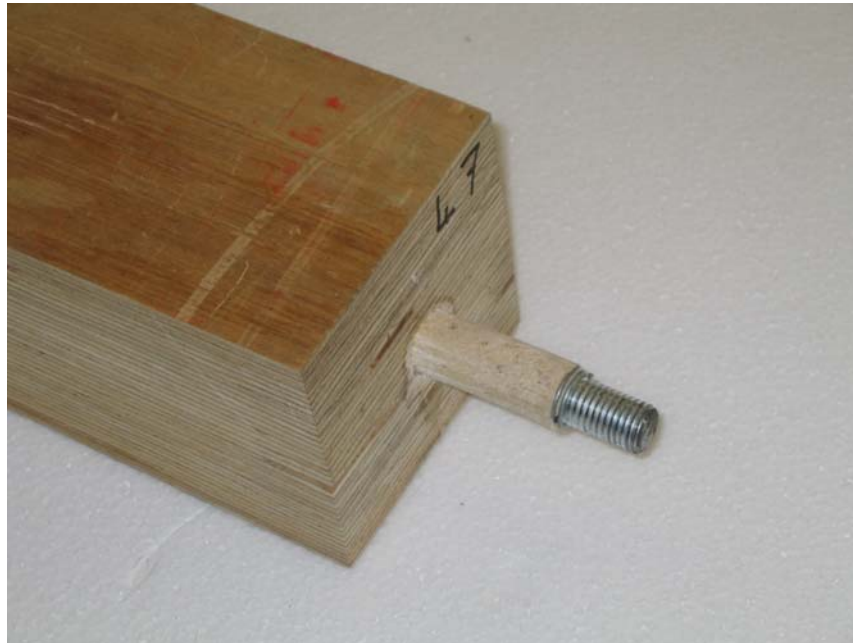
Figure 5.2 Mode 2 failure, typical for HY 150

Mode 2 failures occurred only in the HY 150 tests and was the only failure mode found in tests of the HY 150 system. Figure 5.2 shows this failure mode, with the withdrawn core of adhesive clearly visible.

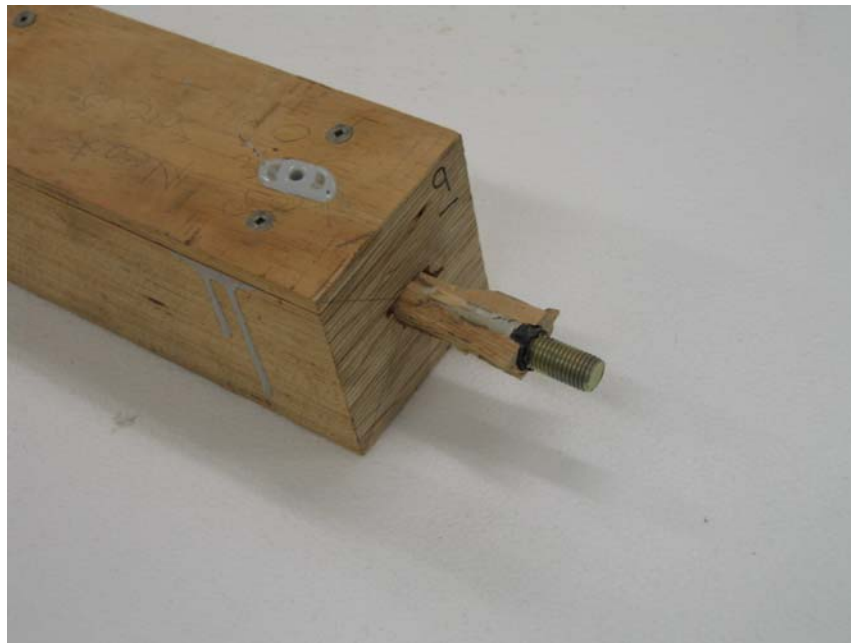
Figure 5.3 Mode 3 failure in West System specimen

annulus of timber surrounding the steel rod, with a thickness of approximately 5 – 15 mm. An example of a mode 3 failure can be seen clearly in Figure 5.3.

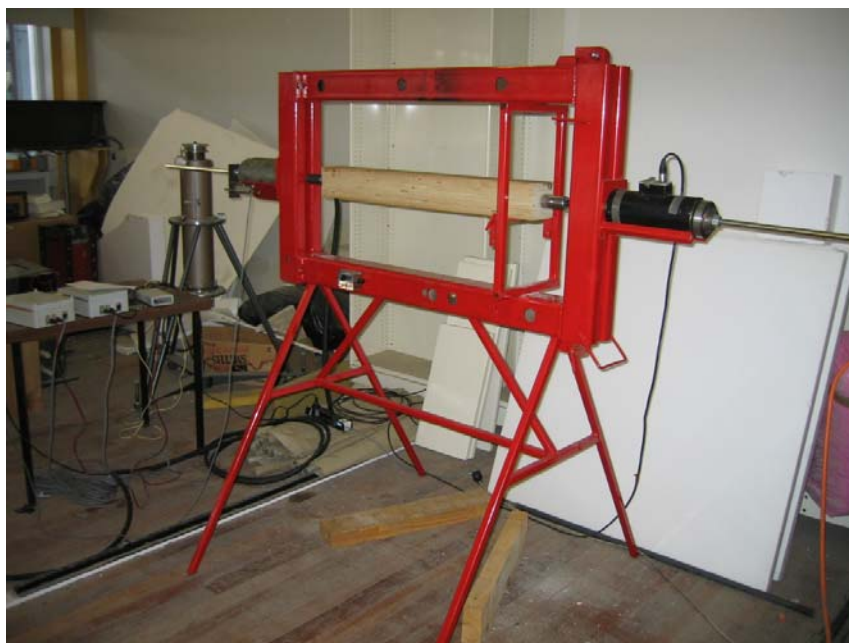
Figure 6.2 Custom-built testing frame, with oven test specimen loaded

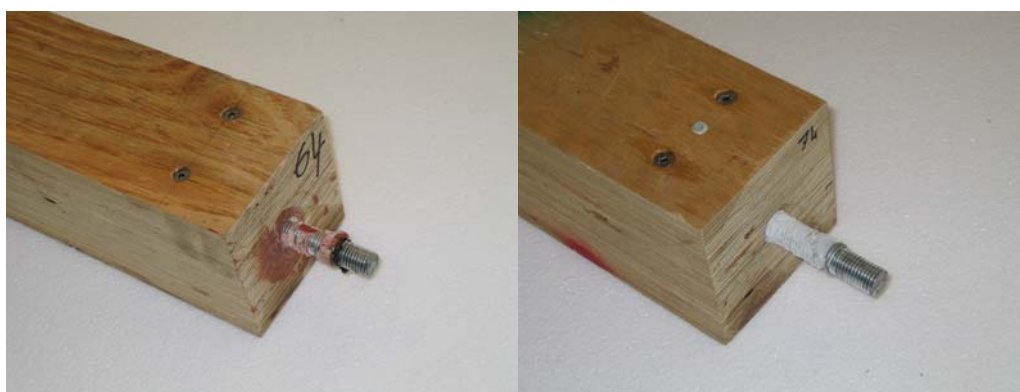
Figure 6.5 Mode 4 failures in RE 500 specimen (left) and West System specimen (right). These specimens were tested at 100 °C

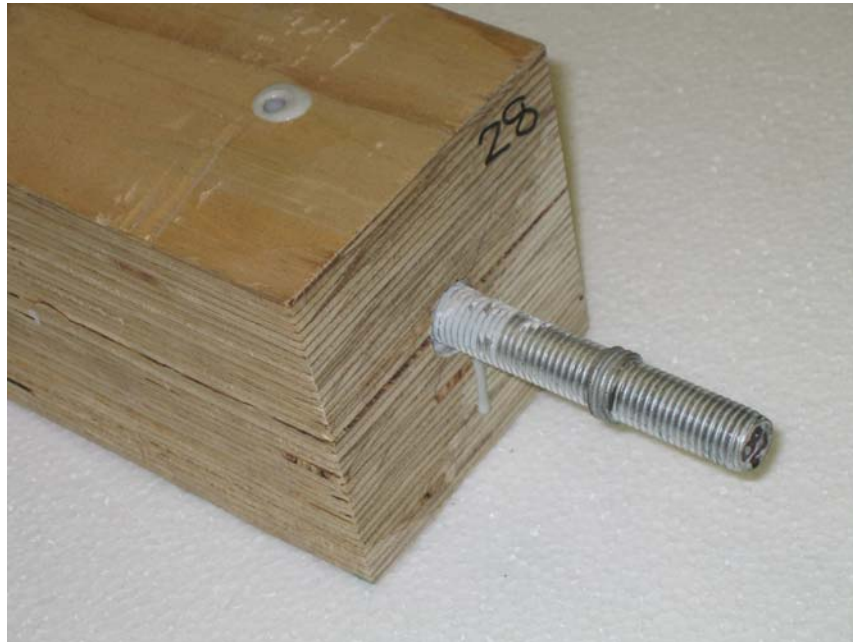
Figure 6.6 Mode 5 failure in a West System specimen

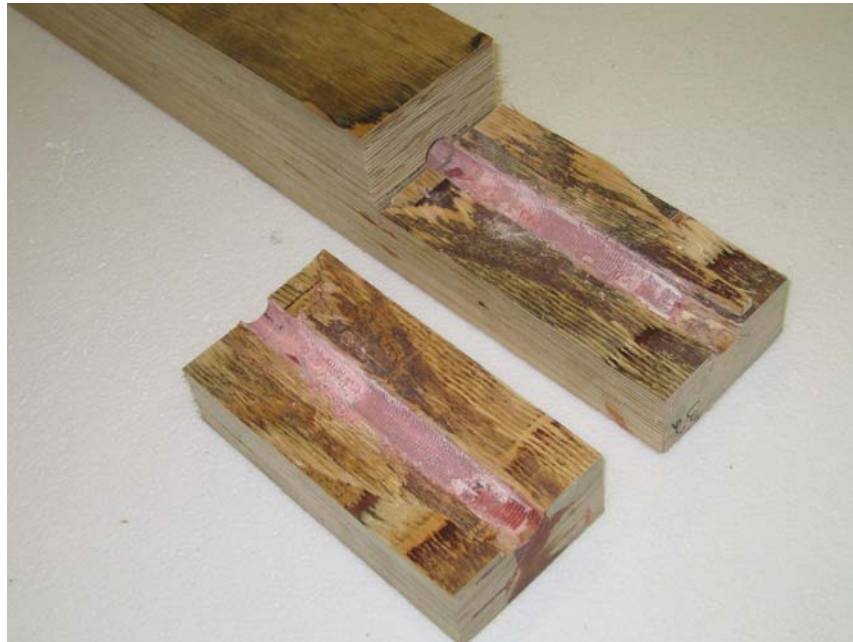
Figure 6.7 Exposed failure surface for mode 5 failure

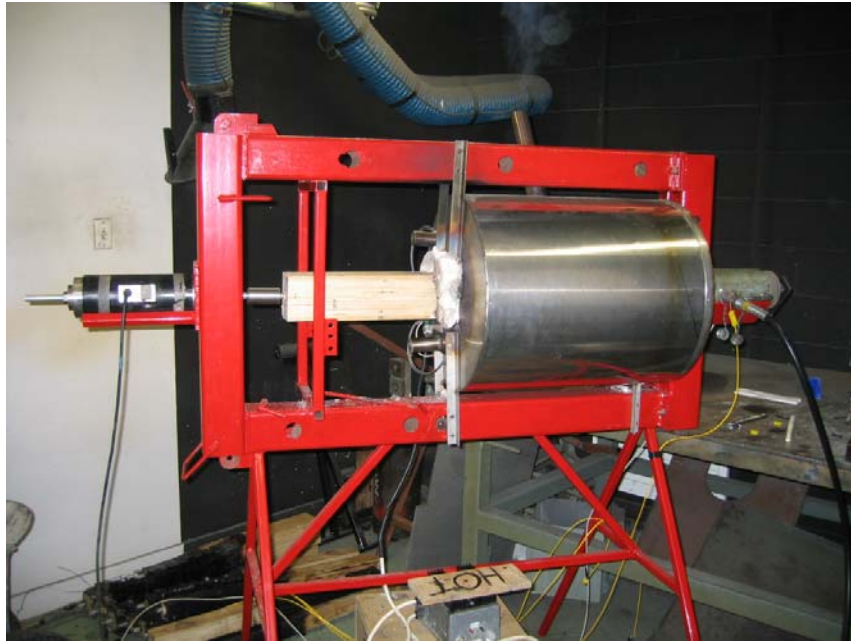
Figure 7.1 Custom-built testing frame with furnace attached

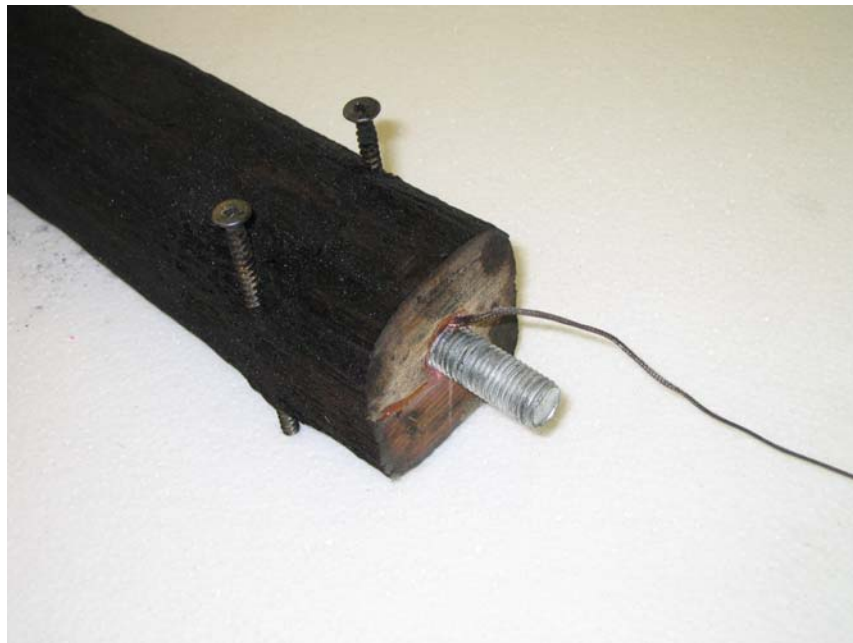
Figure 7.4 Photo showing uncharred end of burnt specimen where protected by Kaowool insulation. The exposed screws show the extent of timber burnt away

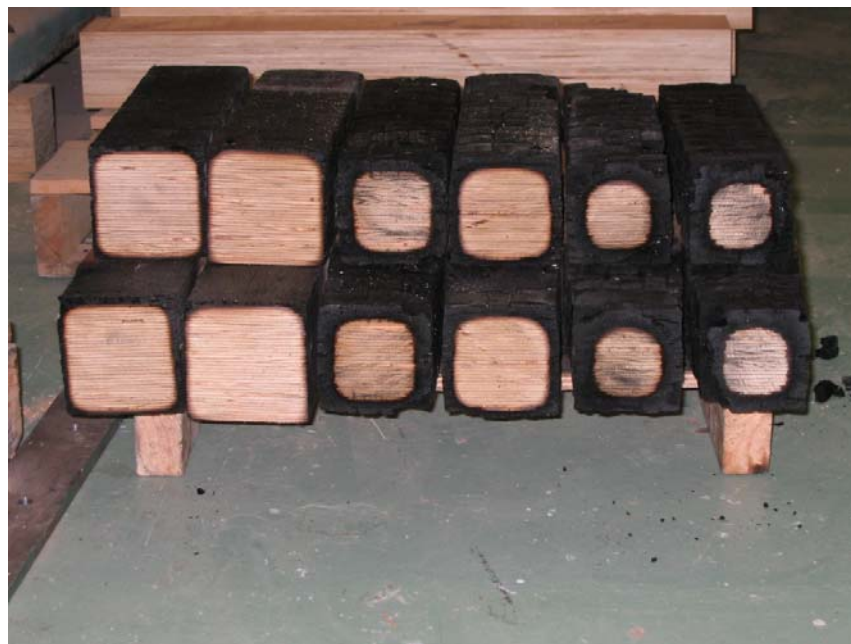
Figure 7.5 Charring specimens after being cut open. From the left there are two specimens exposed for 15 minutes, followed by two at 30 minutes and two at 45 minutes. Note that the top layer of specimens are the matching halves to the lower layer

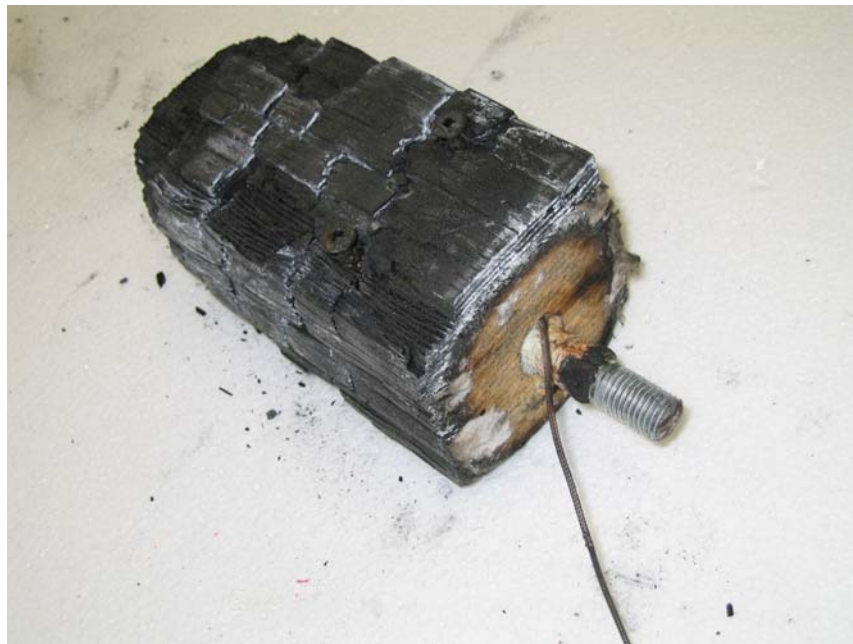
Figure 7.7 Mode 4 failure in portion of a West System 105 x 105 mm specimen

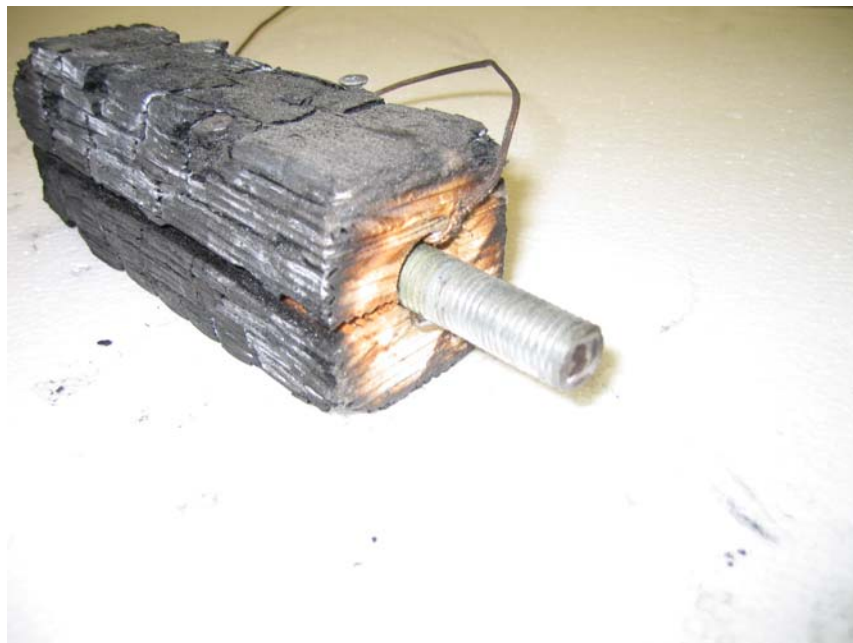
Figure 7.8 Portion of 63 x 63 mm West System specimen showing mode 6 failure

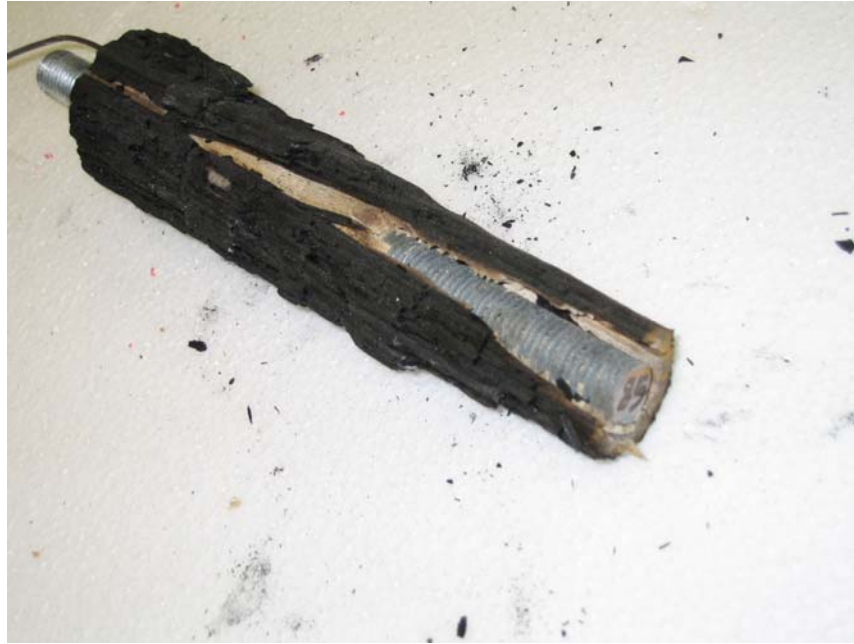
Figure 7.9 Extreme case of mode 6 failure, in a 63 x 63 mm HY 150 specimen

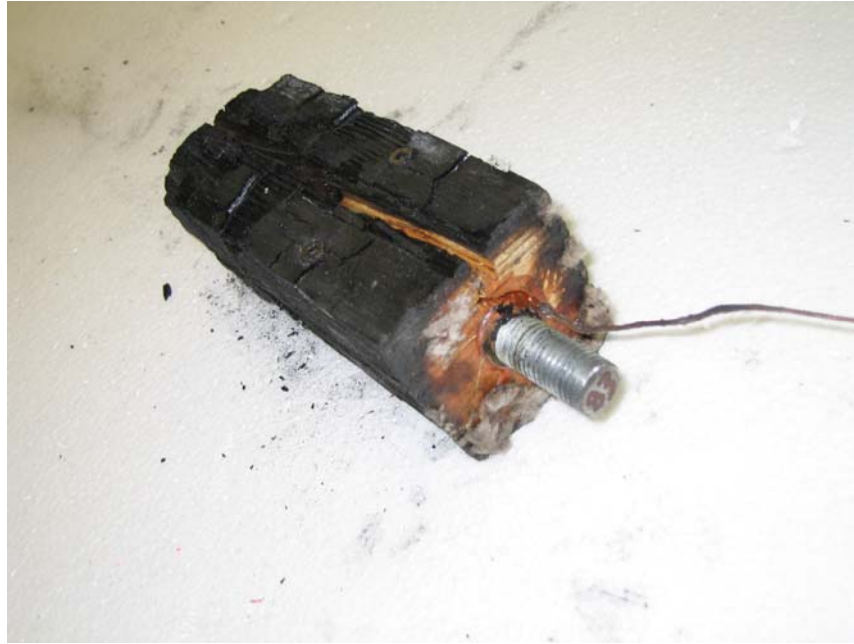
Figure 7.10 Portion of 63 x 63 mm RE 500 specimen with split across laminations in top surface, demonstrating a mode 7 failure

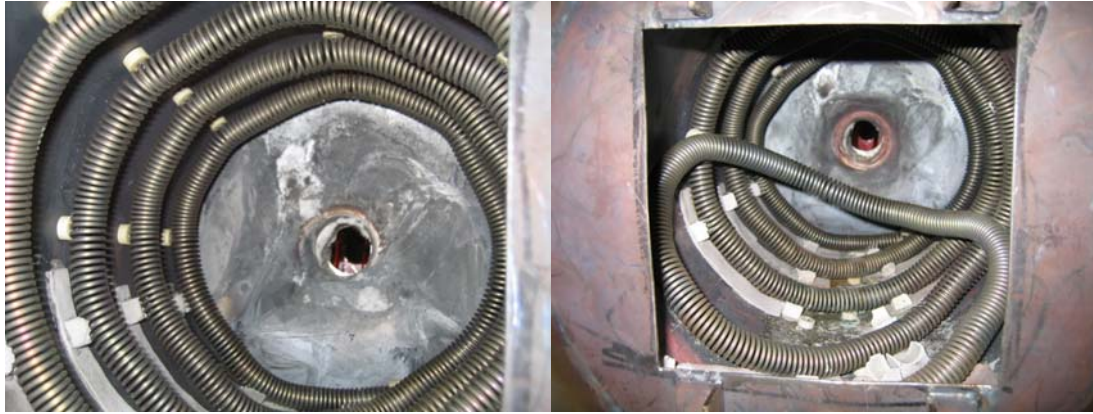
Figure 8.1 Furnace element as built (left) and following severe damage (right)

During this current research it was initially intended that these dowelled connections would be tested in the furnace specifically constructed for this project. Unfortunately irreparable damage to the custom-built furnace occurred during the phase three testing of the epoxy-grouted connections. This damage prevented any tests from being performed using these dowelled connections.
